## MUAYENE - DENYE SONUÇLARI TEST RESULTS

TS EN ISO 10140-2: 2013; TS EN ISO 717-1: 2013

Test Laboratory	TSE Construction Materials Fire and Acoustic Laboratory Aydınlı Mah. Gülenur Sokak No:7/1 Tuzla/İSTANBUL
Requested by	NEVPANEL YAPI MADEN ÜRETİM İTH. İHR. SAN. VE TİC. LTD. ŞTİ. Bağdat Cad. Çolakoğlu İş Merkezi No:458/30 Maltepe / İSTANBUL
Test Sample	NEVPANEL Brand MGO Plate (with gypsum board)

At the request of NEVPANEL YAPI MADEN ÜRETİM İTH. İHR. SAN. VE TİC. LTD. ŞTİ. airborne sound insulation measurements were carried out for **NEVPANEL Brand MGO Plate (with gypsum board)**, at the acoustic department of TSE Construction Materials Fire and Acoustic Laboratory according to TS EN ISO 10140-2: 2013 on 19/11/2018.

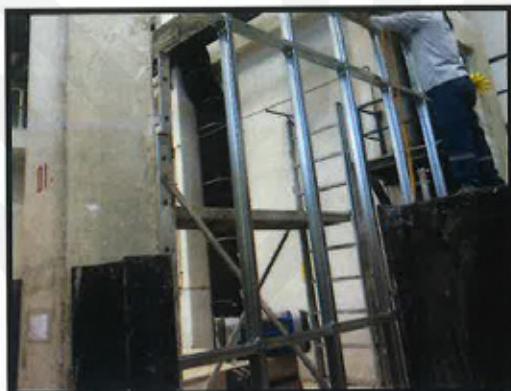
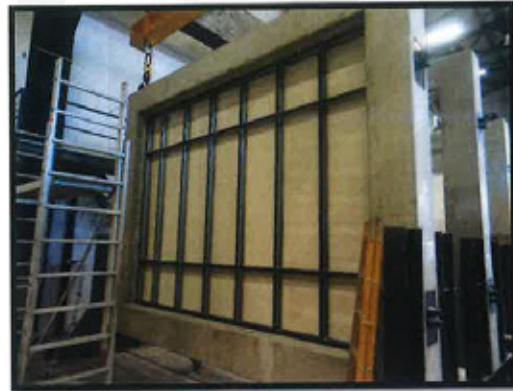
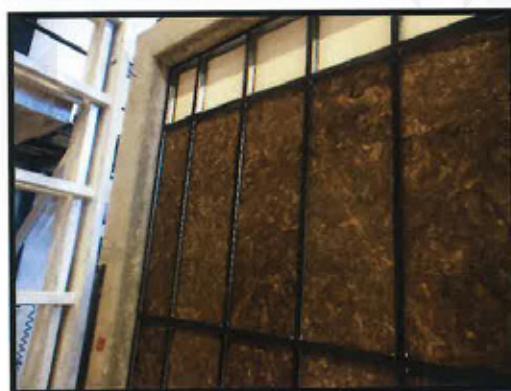
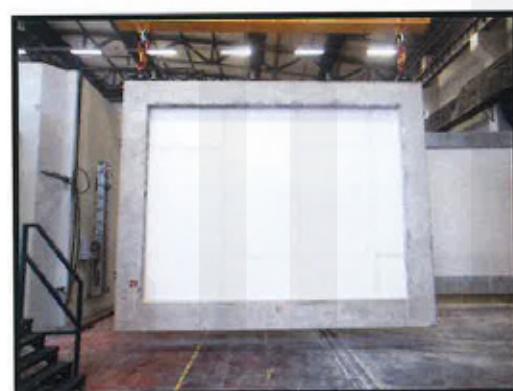
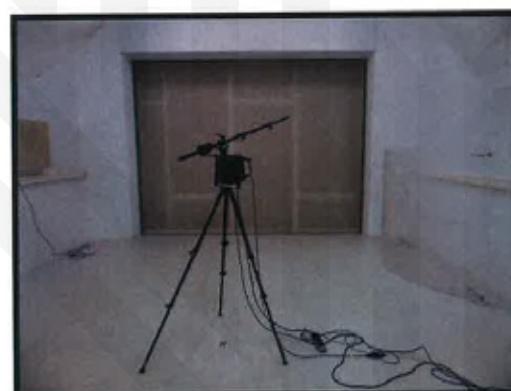
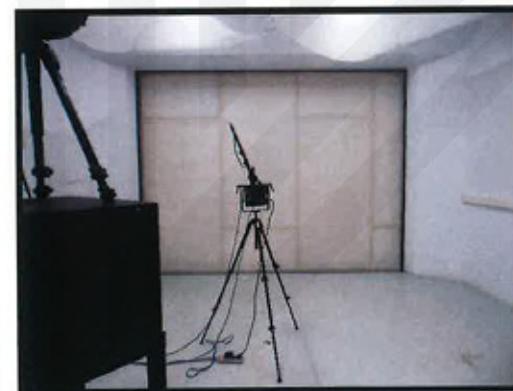
### PHOTOS FOR TEST SPECIMEN IN SEVERAL STAGES

### 3.2 Installation of test specimen

- In order to mounting wall system to the frame, firstly box shape profiles were fixed at the frame via screws.
- After the mounting, insulation tape was used both front sides of the profiles.

- NEVPANEL was used at receiving side and Knauf brand gypsum board was used at source side in such a way that joints would not overlap each other on both sides.

- Knauf Insulation brand mineral wool with 50 mm thick was placed in the gap between two sides of the wall.
- Gypsum joint filler was applied on the joint tape which was used at joints of the gypsum boards.

- Green Glue noiseproofing sealant was used between sample and frame junction points at both sides.
- The ratio of the niche depths on either side of the test element is approximately 2:1.
