## DENEY RAPORU

AB-0556-T

Fire resistance test, in conformity with the general requirements of standards EN1363-1:2012, with substitute or additional methods of standard EN 1363-2:1999 and with the particular requirements of standard EN 1364-1:1999 "Fire resistance tests for non-loadbearing elements- Part 1:Walls".

Product identification: Partition Wall System Consisting of Single Layer of MgO Panels – "**NevPanel, DragonBoardTürkiye, MagnumBoard**"

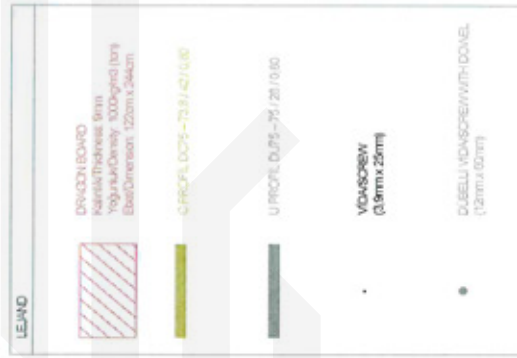
Figure 2: Details of the materials

Figure 3: Cross section view of the test specimen.

See Figure 1-3 for details.

For further information, see figures 1-3.

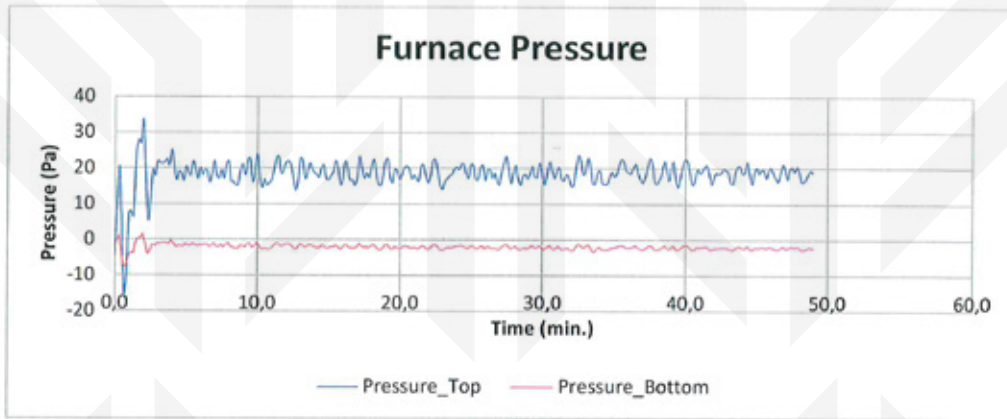
Figure A3: Pressure in the furnace

The target overpressure in the furnace was 0 Pa at 500 mm above floor level and 19 Pa at the top of the test specimen.

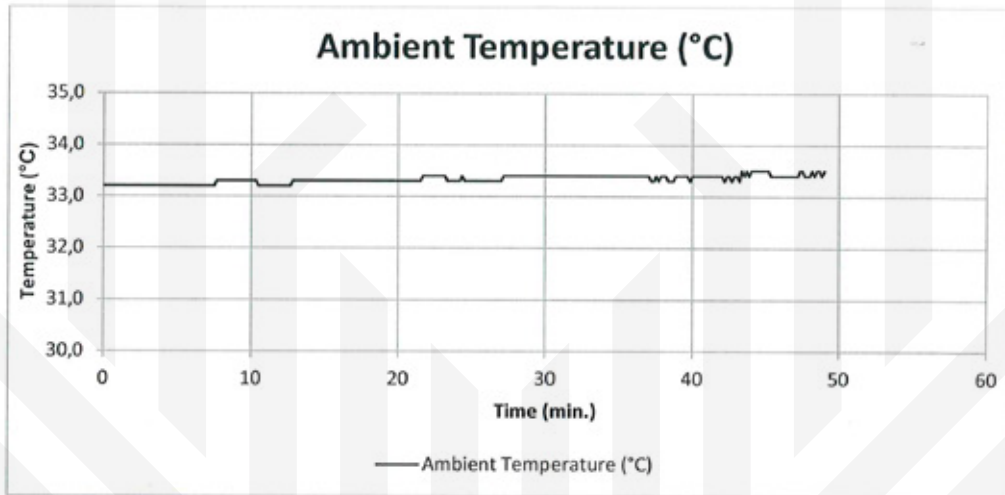
Figure A4: Ambient temperature at laboratory

During the heating the temperature in the laboratory complied with the standard EN 1363-1:2012.

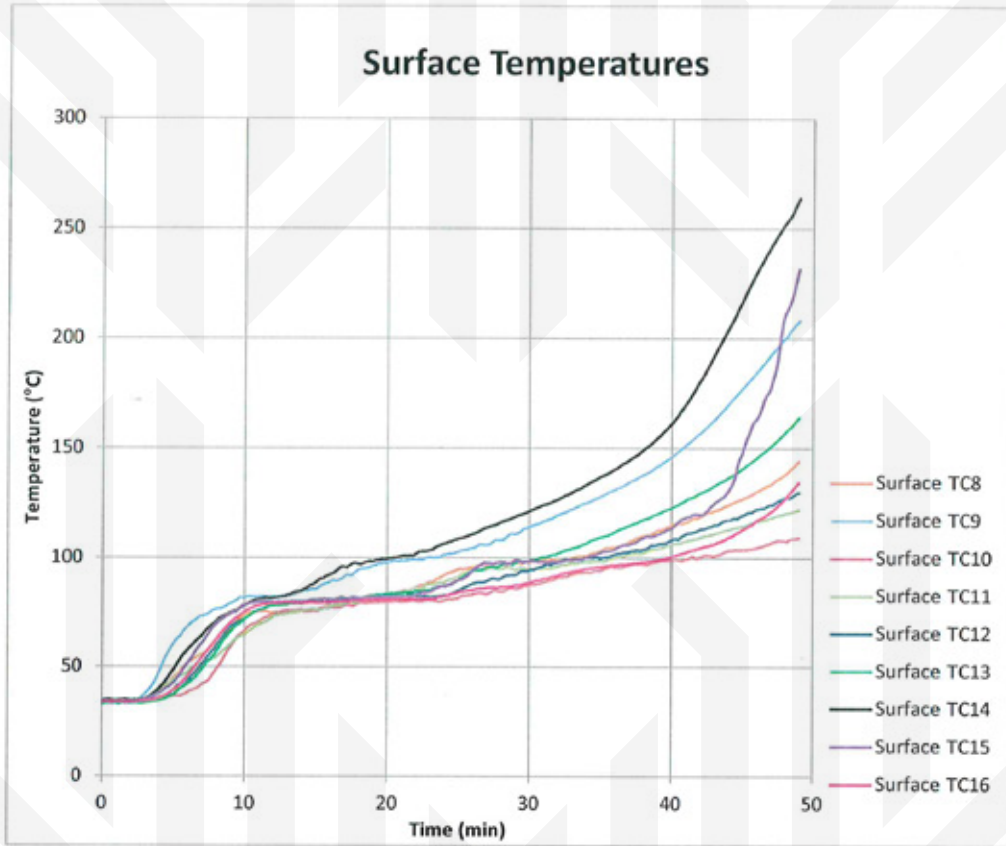
Figure B3: Surface temperatures (Thermocouple sensors for maximum temperature)

Integrity, (E)	
- Cotton pad	48 <sup>th</sup> minute.
- Gap gauges $\varnothing$ 6 mm	no failure (not applied)
$\varnothing$ 25 mm	no failure (not applied)
- Flames longer than 10 sec.	not observed.
Insulation:, [I]	
- average temperature	48 <sup>th</sup> minute due to the failure of Integrity
- maximum temperature	46 <sup>th</sup> minute by TC 14.
The heating was terminated at 49 <sup>th</sup> minute after consulted with the customer.

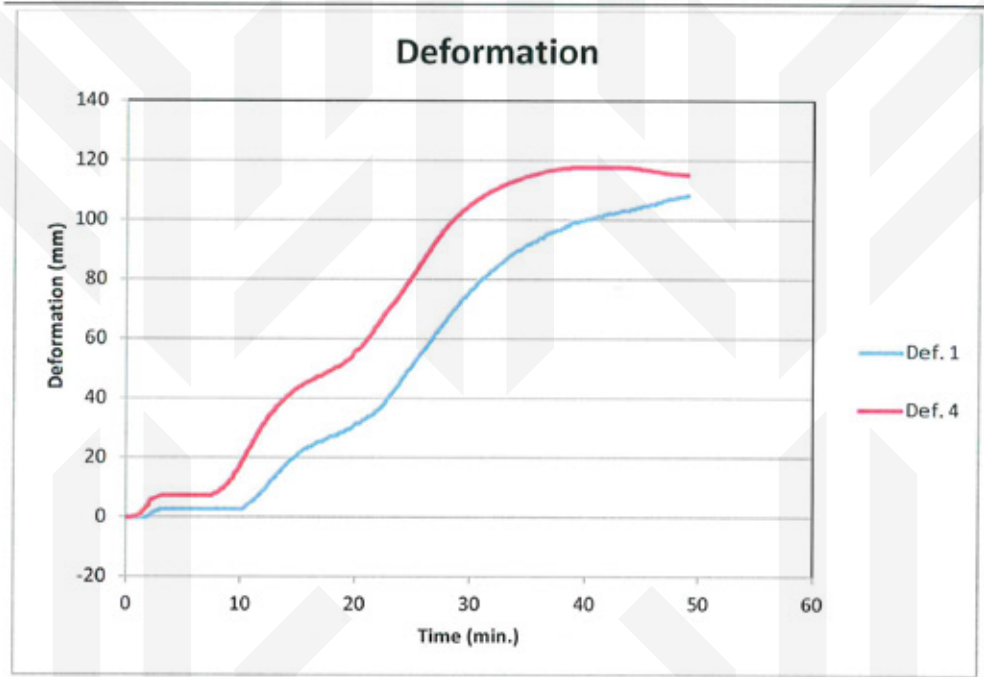
Figure B4: Deformation of the wall.

The height of the construction may be increased to 4 meters for a fire resistance of **20 minutes** for the criteria integrity and thermal insulation, because the lateral deflection of the construction is less than 100 mm. See Table B1 – Appendix B.

Time (min)	Def. 1 (mm)	Def. 4 (mm)
0,0	0,00	0,00
2,0	0,38	4,10
4,0	2,75	7,38
6,0	2,78	7,38
8,0	2,78	8,28
10,0	2,78	17,48
12,0	9,10	31,15
14,0	17,90	40,38
16,0	23,83	45,70
18,0	27,33	49,63
20,0	31,55	55,85
22,0	36,08	64,68
24,0	46,28	75,28
26,0	56,65	86,78
28,0	67,15	97,68
30,0	76,35	105,10
32,0	83,28	109,95
34,0	89,45	113,33
36,0	94,13	115,83
38,0	97,43	117,53
40,0	100,45	117,88
42,0	102,38	117,90
44,0	103,85	117,80
46,0	105,43	116,58
48,0	107,70	115,60

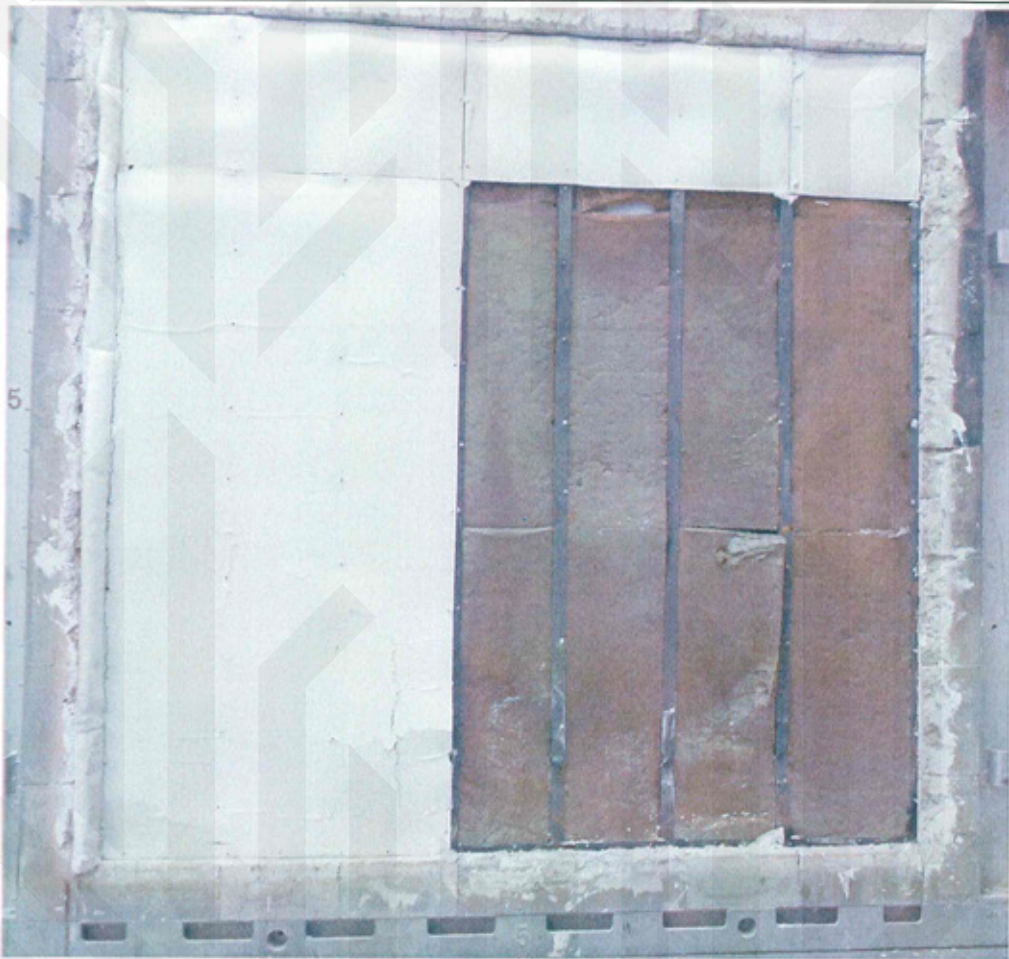
Photo C5: Exposed side of the test specimen after the test

0	Heating started. <b>See photo C1-C2.</b>
13	Smoke release at edge of the specimen.
29	Deformation at middle panel increased $\approx 10$ cm
31	Joint tapes started to remove from the panels.
33	Opening at fixed edge between panels and test frame.
38	Horizontal joint cracked and blackened.
40	Cotton pad was applied to opening zone at fixed edge. No ignition.
46	Temperature increased at Thermocouple Nr. 14, $\Delta T > 180$ °C. <b>Insulation (I) failed.</b>
48	Opening at the horizontal joint. Cotton pad was applied, ignition. <b>Integrity (E) failed.</b>
49	Test was terminated after consulted with the customer. <b>See photo C4-C5.</b>
